# Influence of Temperature and Operation Time on the Fatigue Strength and Microstructure of Welded Joints of A-387Gr.B Steel

Article in *Materials Science* · November 2021

The main aim of our paper is to analyze the influence of temperature and service time on the fracture resistance of welded joint constituents for new and exploited low-alloyed A-387Gr.B steel (Cr–Mo type) under the action of dynamic load and changes in the mechanical properties. The exploited parent metal, as a part of the reactor mantle, is in the damage repair stage, i.e., a part of its mantle is replaced with a new material. Wohler's curves were constructed, i.e., the fatigue strength as material resistance to crack initiation, was determined at the room and working temperatures. Testing of the welded joint and microstructural analyses of the parent metal, weld metal, and the heat-affected zones were carried out. Based on the testing results, the analysis of the fracture resistance, and the microstructural changes, represent the comparison of values obtained for the characteristic areas of the welded joint and the justification of the selected technology of welding.

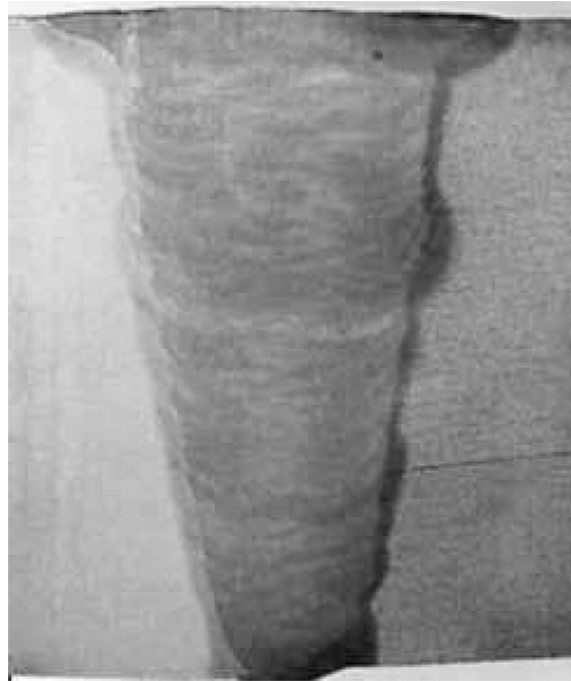
**Fig. 4.** Macrorecording of welded joint.

joints depending on the variations of the microstructural properties. The macrorecording of a butt welded joint of the new PM and exploited PM is presented in Fig. 4 [1].

After etching of the butt welded joint, we can clearly distinguish the new and exploited parent metal; the heat affected zones on both sides, and the weld metal with well-marked groove filling zone.
